Happy Thanksgiving! (2012 Newsletter, Published October 2014)

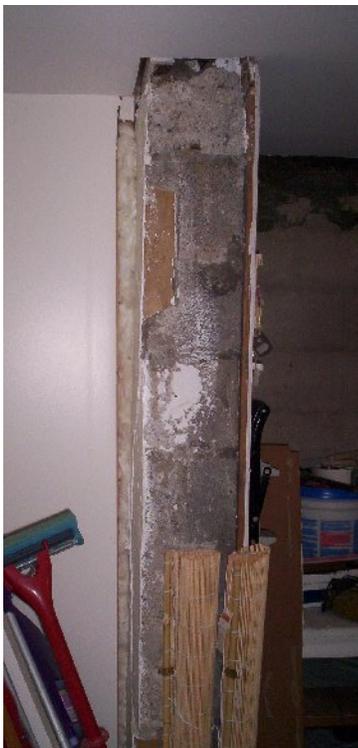
The next stage involved removing as much of the old kitchen as possible, while maintaining some of the kitchen in usable condition for as long as possible. I included the photo on the left, pardon the mess, to show why I had so much trouble taking early measurements. When I made a measurement across the old existing counter top, through a hole in the drywall to the blocks, I got a different measurement than I obtained later at ceiling level.

The new sheet of drywall in the finished patio room is perfectly vertical, and even trimmed slightly at the bottom right corner. This wall was on the exterior of the house, to the left of the rear entry door.

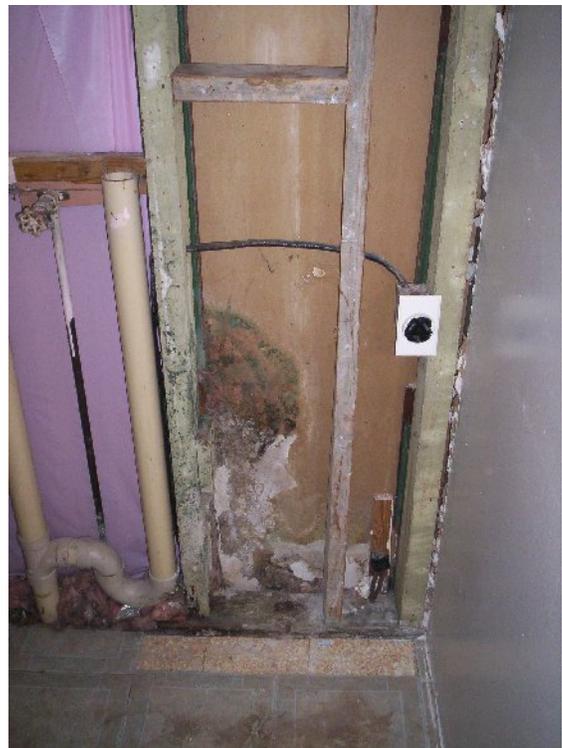
I hate showing some of the mess I encountered, but it explains a lot about the wall being so far out of plumb. The light green vertical studs in the right photo measure a full 2"x4" plus an additional 3/4" dark green flooring plank is placed behind the vertical studs only on three studs. This added width was probably necessary to install the drain for the washer. Also note the capped and taped old electrical wires hidden inside the wall. This is just one reason why I abandon existing wiring and completely rewire a house with new Romex.

If you are curious about the pink sheet of plastic. As you can see, the drywall, lower studs, and flooring are deteriorated from the drain overflowing on occasion. Back when I remodeled the master bedroom, I replaced this section of drywall, which is inside the back wall of a closet. Finding no leaks, and to ensure no moisture got into the closet until we redid the kitchen, should the drain overflow again, I lined the wall with plastic before replacing the drywall. If I recall, I used green board in this area as a secondary safety measure as well.

The wall thickness of this north facing wall ranged from 4-1/2" to 6-1/4" on the kitchen side. The bedroom side was fairly close to plumb. The lengthy 2005 Newsletter shows the bedroom renovation.

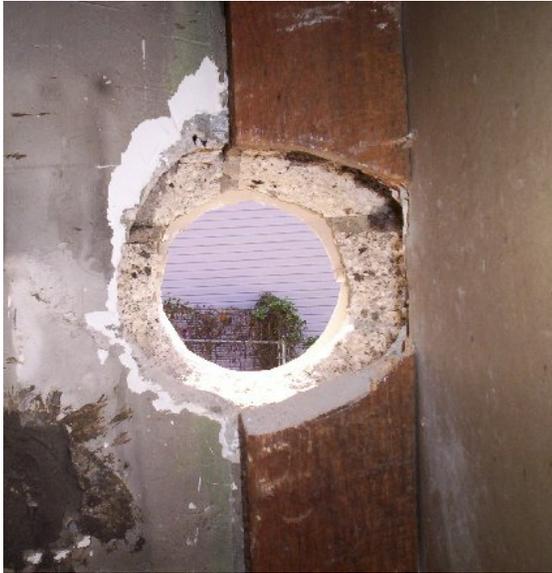
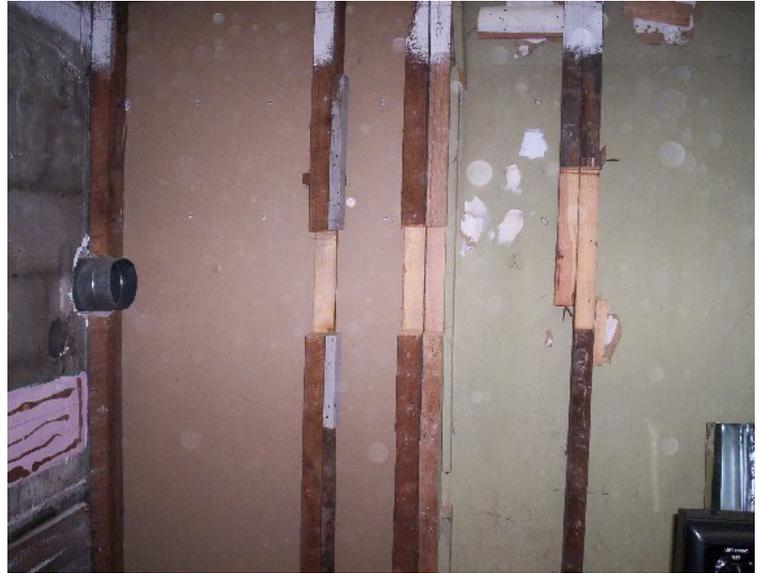
Some concrete blocks are solid and/or filled with concrete, anything to make the job harder. It took me a long time to get through since I run out of energy so fast. The right picture shows the slots cut in the studs for the rectangular ductwork to pass through. They will be reinforced again later in the project.

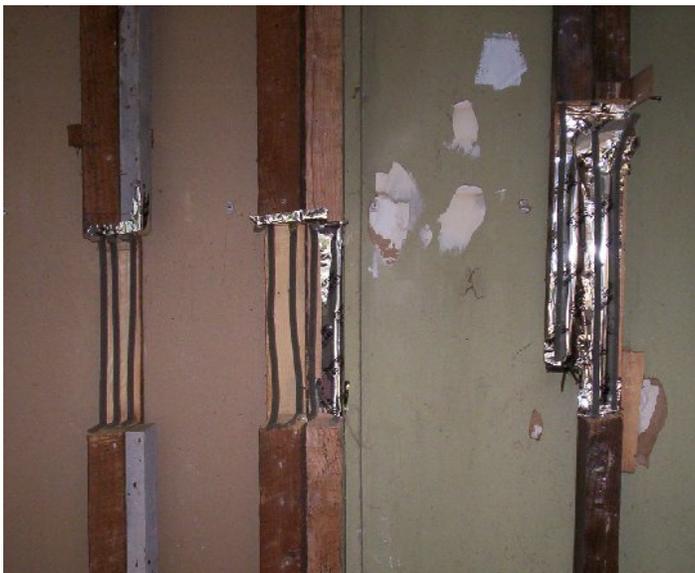
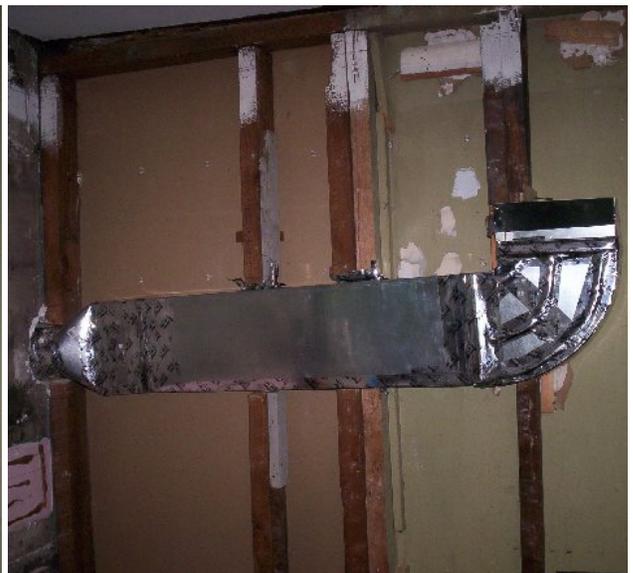
To prevent a rattle inside the walls, I placed foam between the wood and ductwork and covered with mylar duct tape. Soft liquid foam will also be used after all the studding is in place. I also placed the foam and tape over the side of the ductwork facing the camera. The transition piece from rectangular to round will receive a poured in liquid polyester to prevent grease puddling inside this area.

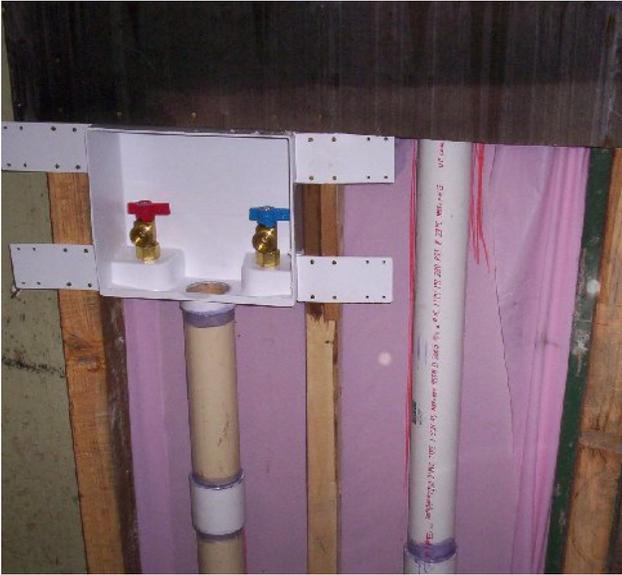
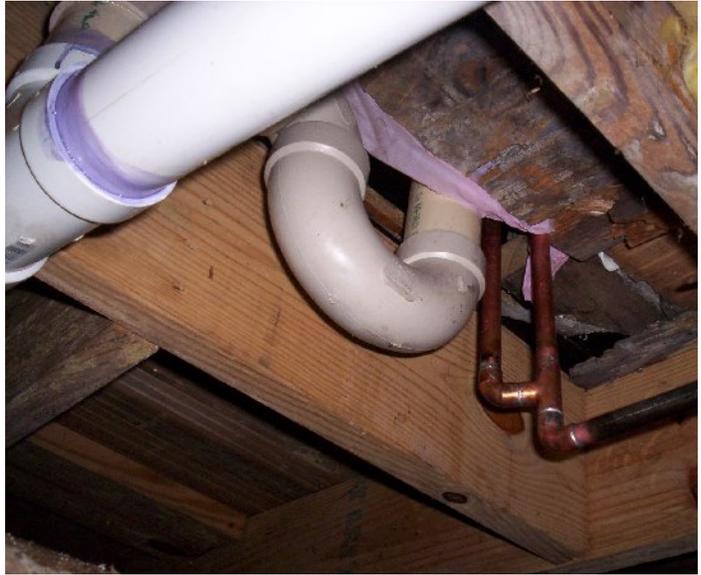
On this same wall, to the right where the original plumbing was located. I tore out the existing waste and supply plumbing, then relocated the original trap and standpipe to under the floor. This required repairing the floor joist and adding a cross member for support. I also replaced all the original cast iron to the main vent stack with PVC. Yes I'm very sloppy with the purple cleaner. I learned years ago if you are too neat, the blind inspectors will say you didn't use enough. Both the hot and cold water supply lines have a long anti hammer tube. It stops noise and extends the life of solenoid valves.

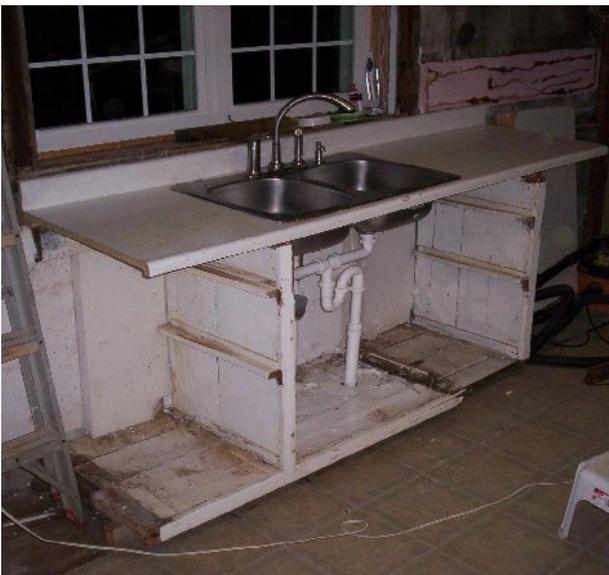
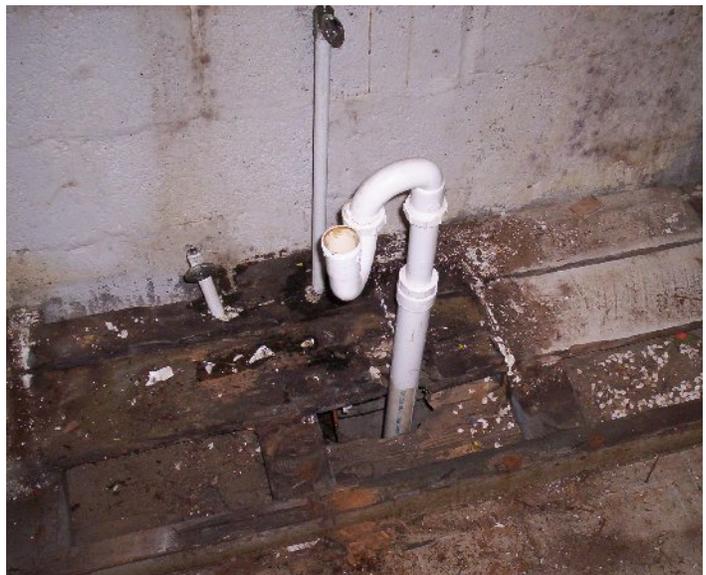
Before I could complete the sanitary plumbing connections, it was time to remove the last remaining section of the kitchen cabinets, the sink base. I won't get into the things we found under these cabinets, but the condition of the flooring under the sink truly was a surprise. The wood was so deteriorated you could crumble it in your hands like a sugar cookie. The old iron pipes were so brittle, I did not need to cut them with a saw, a sharp yank and they snapped right off. All of the sanitary waste plumbing will be replaced and vented through a new stack. Our new kitchen design includes a deep sink, disposal, dishwasher with it's own waste and water lines, and a direct line to the ice maker. The new kitchen windows are filled with UV and solar heat protecting gas to four or five times the normal level.

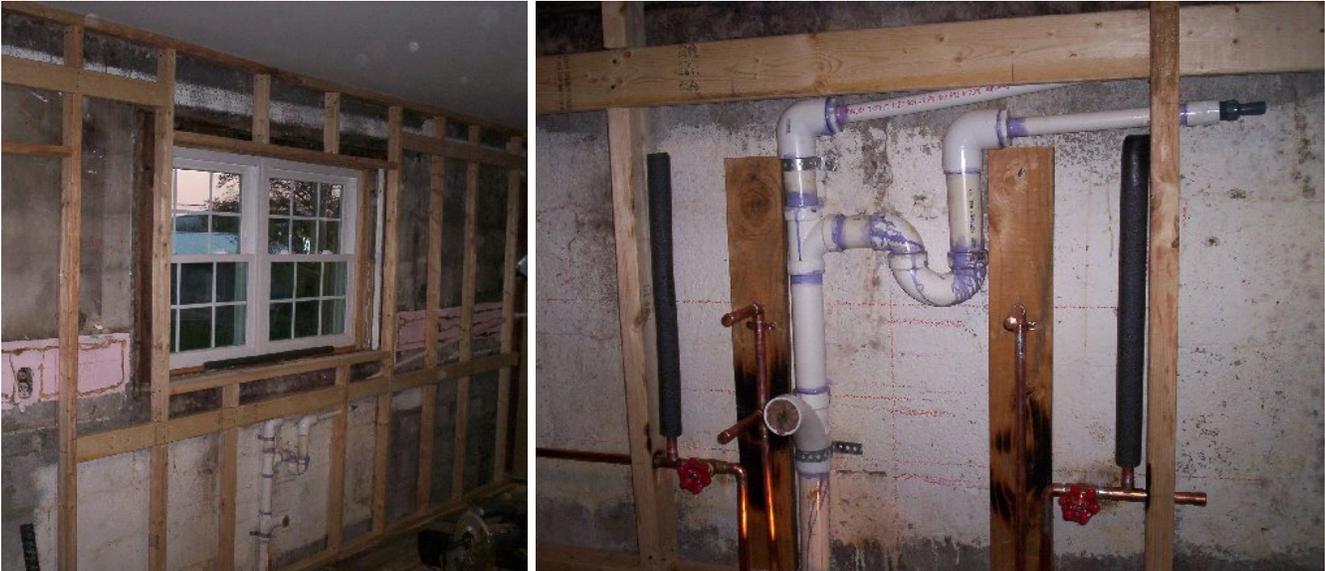
In the left image, the stud closest to the left, without a lower cabinet mount rail, will be the refrigerator alcove. Likewise, the connections for the dishwasher are in their own little alcove. Neither the floor or ceiling in this house is level, thus the reason for the painted white line near the ceiling to draw a level line across. The horizontal studs are for the cabinet mounting rails. The vertical studs on this wall are not on sixteen inch centers, they are aligned with the edges of the individual cabinet units.

To appease the plumbers who may be viewing the waste plumbing in the photo above, it is properly vented. The wet vent distance under the floor, before reaching the dry stack-vented branch arm to the main or common vent stack is under twenty inches. The original DWV was only wet vented and passed code. When I replaced all the old cast iron with PVC, I chose to add the additional dry vent. The visible trap in the photo is for the dishwasher waste connection. Dishwashers already have a vent loop, some even use an above the counter AAV, which are legal if used on a dishwasher as a vacuum breaker, but not as a plumbing vent. Code did not require any further venting than what I already supplied. So what's with the auxiliary revent pipe that is undersized to pass code? Because the DWV system already passes code without a revent pipe, technically it is not a revent pipe at all, but is used as a vacuum breaker for the dishwasher. It runs steadily uphill to the stack-vent for the washing machine.

The copper tubing is the more interesting than waste plumbing any day. The red knob on the right is a hot water shut-off to the dishwasher, and the anti-hammer tube is covered with foam rubber to prevent a rattle against the wall or stud. The red valve to the left is a cold water shut-off to the refrigerator. By running half inch tube all the way to the refrigerator, you have less resistance than using ice-maker hook-up kit tubing. Although we are talking low volume usage, I still installed an anti-hammer tube here as well, because of the solenoids in the refrigerator. You will recognize the two standard stub-outs for the kitchen sink faucet, to which shut-offs will be added later. The longer stub-out below, on the hot water side, will go to a full-pressure fill-valve for filling mop and other buckets. I use a lot of hot water on some of my projects and this extra outlet is beneficial. I should have added one on the cold water side for the dogs water, but I normally fill it from a tub spout added for that purpose.

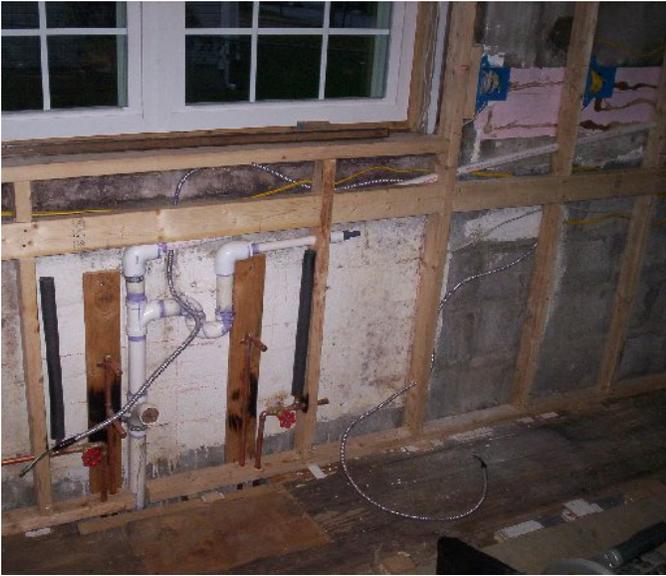
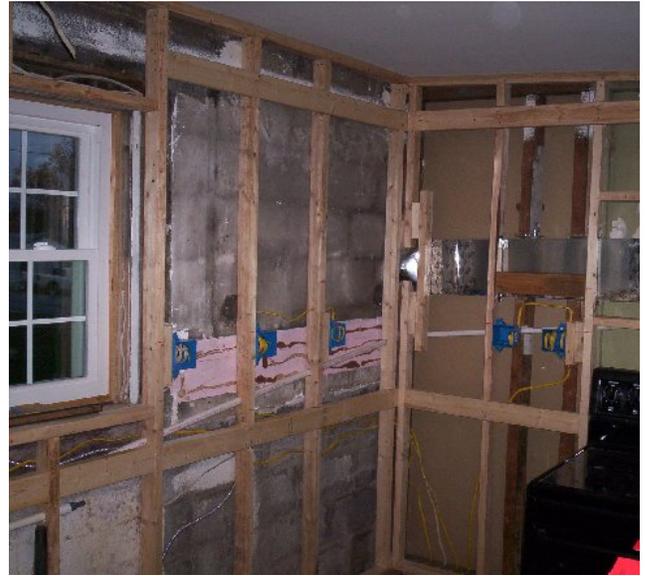
Next on the agenda, after repairing the floor under the sink, I installed the pull-boxes and rough-in for the wiring. All measurements are made from the level line drawn around the perimeter of the room, where the top rail for the upper cabinets is located. This was necessary because the floor is not level. Once the wiring was in, I installed spacer blocks on the floor, under what later would be the four corners of each cabinet section, and elsewhere as needed. These spacers were both nailed and glued in place. The photo on the right shows the studs and added bracing over the hood vent ductwork. Both of the two blue pull-boxes closest to the corner, representing eight electrical outlets, will be inside the corner cabinet garage. One can never have enough outlets, evident by my earlier bathroom renovation.

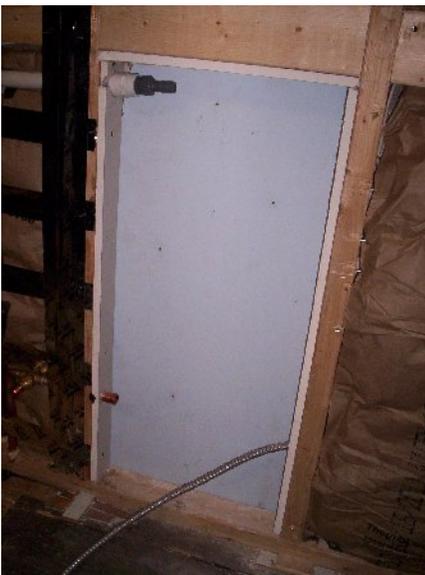
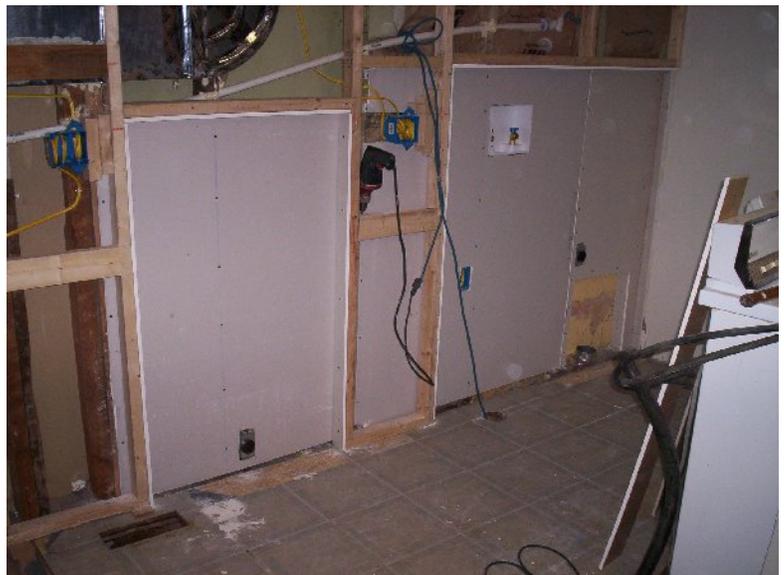
Everyone knows what insulation batting looks like, so if some appear in the images, they are merely coincidental to show something else. These next two pictures are to show the alcoves. On the left is for the dishwasher hook-up, the right alcoves are for the range, washer and dryer. Note the second smaller alcove for the dryer vent, to ensure the dryer ends up flush with the counter top front. Working in a house with walls so far out of plumb, and sloped flooring, taking measurements at such tight tolerances, and getting the blueprints just right was an engineering nightmare.

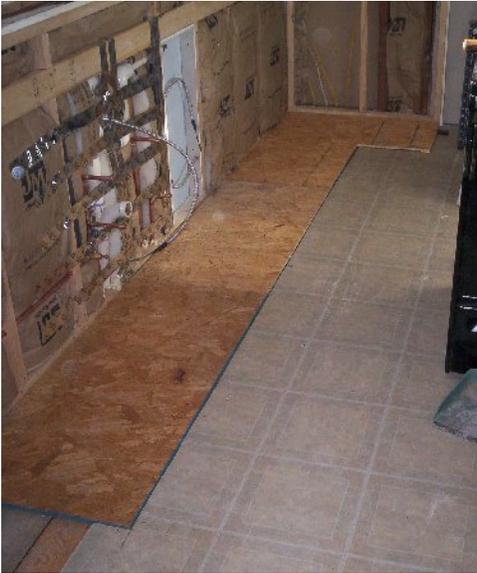
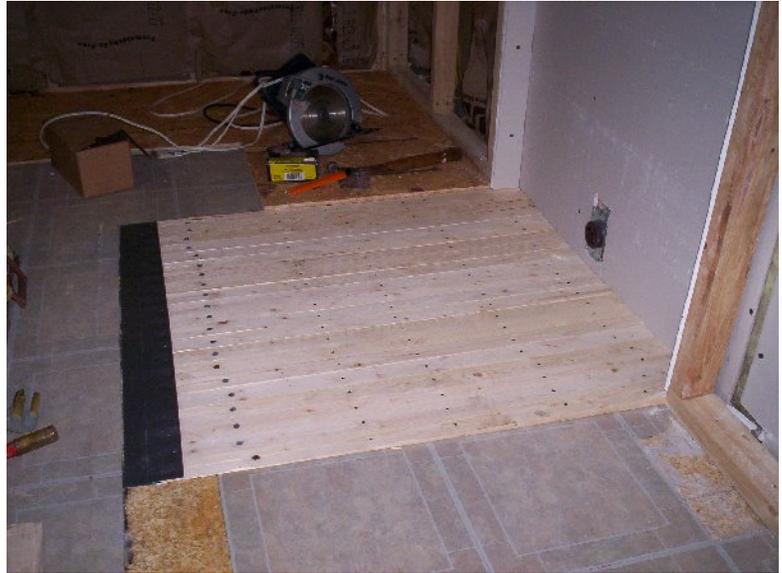
I'm still a long way out from buttoning up the new kitchen with drywall. The base for the cabinets came next. For reference, the lower corner of the new wood closest to you, at the bottom of the picture, is flush with the original finished floor at this point. The purpose of the spacers under this new wood is to make the base the cabinets sit on perfectly level. The floor slopes downhill to the right of the ell, and dips sharply toward the north wall from about three feet.

My brother-in-law Everett graciously cut the several wedges needed to bring the floor up to level. The compound slope in two directions in this area required several measurements and adjustments. The image of long triangular wedges make the floor appear to slope uphill after the wedges were in place. However, if you look at the edge of the base for the cabinets, you can see not only are the wedges level, but they are also slightly lower to make up for the final finished flooring material.

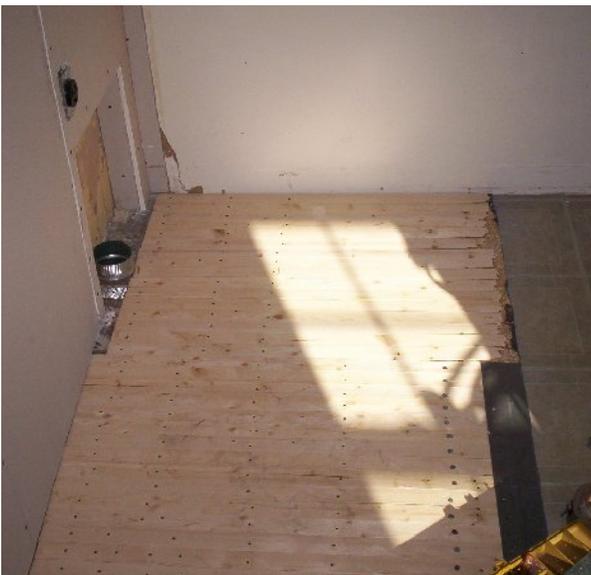
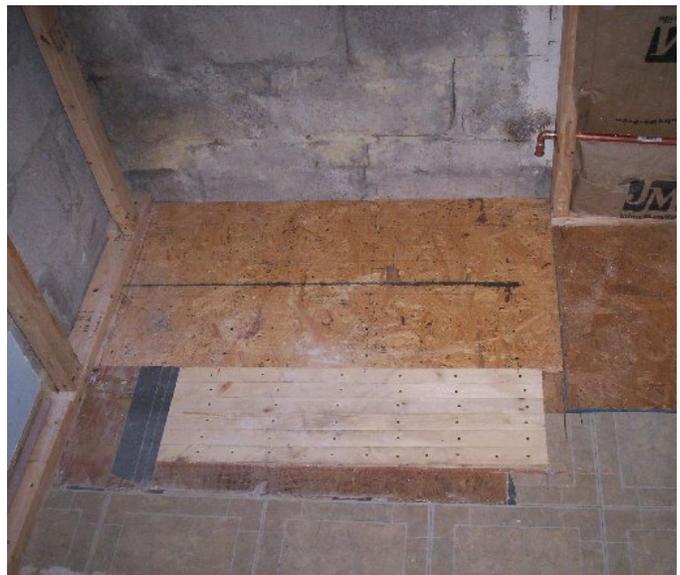
There are six nails in each of these long wedge triangles, and two layers of the original flooring were removed to ensure the thin tapered ends are below the old vinyl squares. I snapped one photo of the unfinished corner to show the raw taper ends. The photo on the right is where the refrigerator will go. The new flooring piece will butt against the new cabinet, and the wedges make the area level.

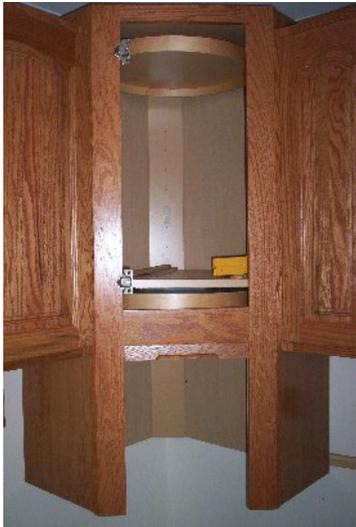
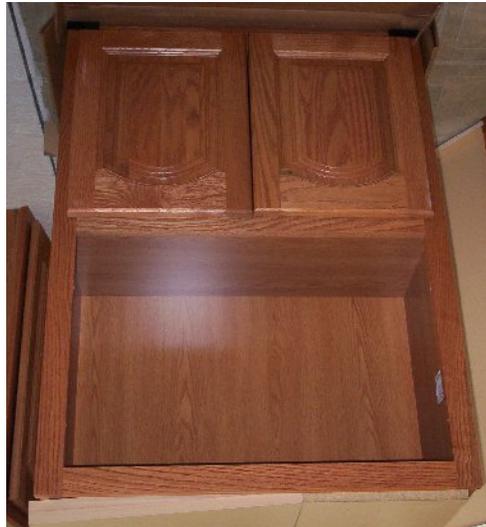
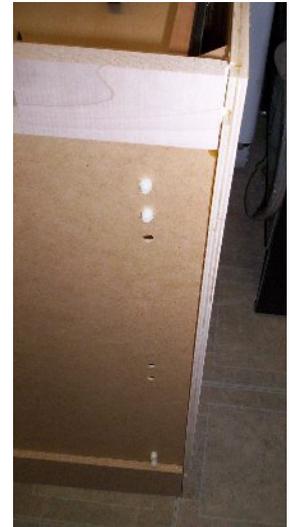
Not everything goes as planned. Sometimes the materials are assembled by idiots. In the first image, the bottom lazy susan is OK. But how does one use the top one? I guess it is designed for anti-gravity spices! The microwave cabinet in the center image has the doors upside down, easily fixed. Hard to tell in the right photo, but this cabinet is 1-1/4 inches larger at the bottom than at the top, oops. A roll out drawer cabinet came with a center post, a set of stacked drawers, with the drawer fronts installed sideways, and the left right island cabinets came with two lefts and no right. To make matters worse, there was something wrong with each and every new appliance. The sent out five ranges before they said no more, live with the dents. The wire lower basket inside the dishwasher was smashed, could not possibly be shipping damage inside the unit, and it took two years to get the dryer repaired.
